This spreadsheet performs screening level calculations to estimate the effect of peeling leaded paint on the average concentration of lead in yard soil  
4957 Clayton St.

## LBP Assessment Results

Property ID # 2576 / 4957 Clayton Street

SITE NAME: VASQUEZ BLVD AND I-70

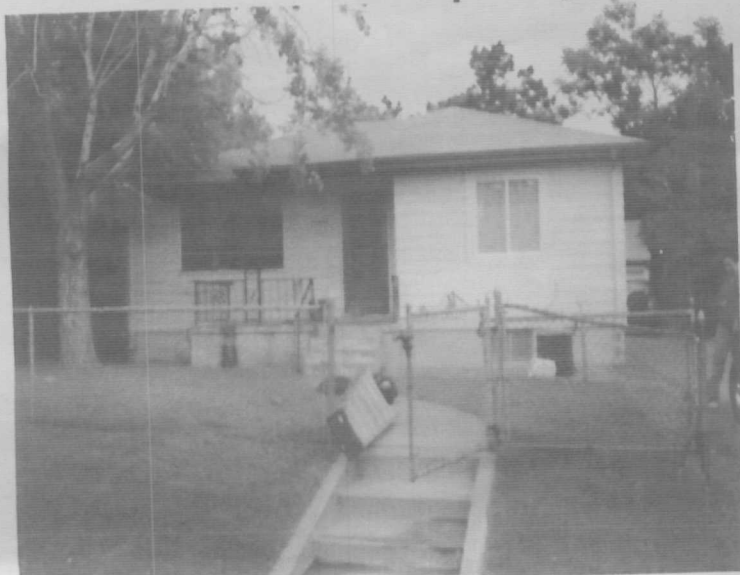
East porch exposure of house

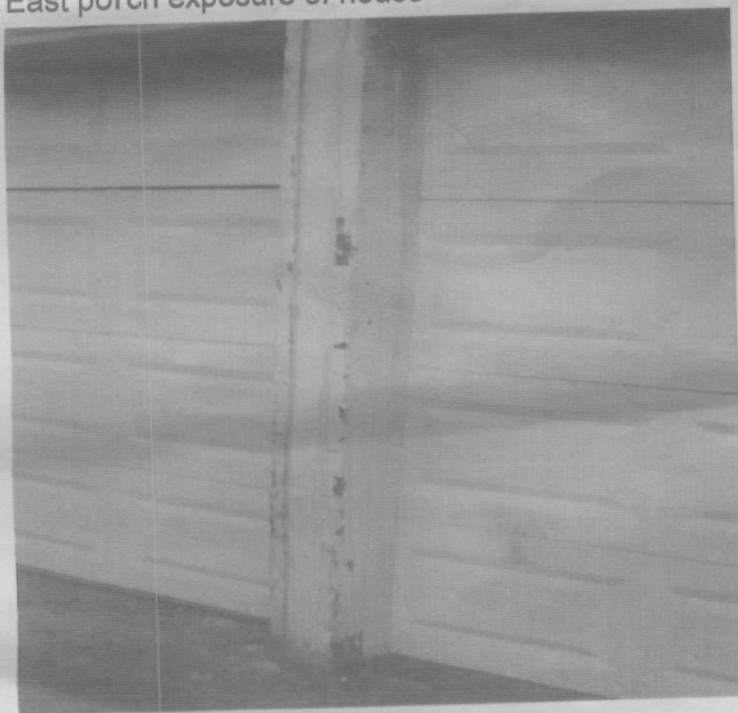
Garage doorframe contains peeling lead paint

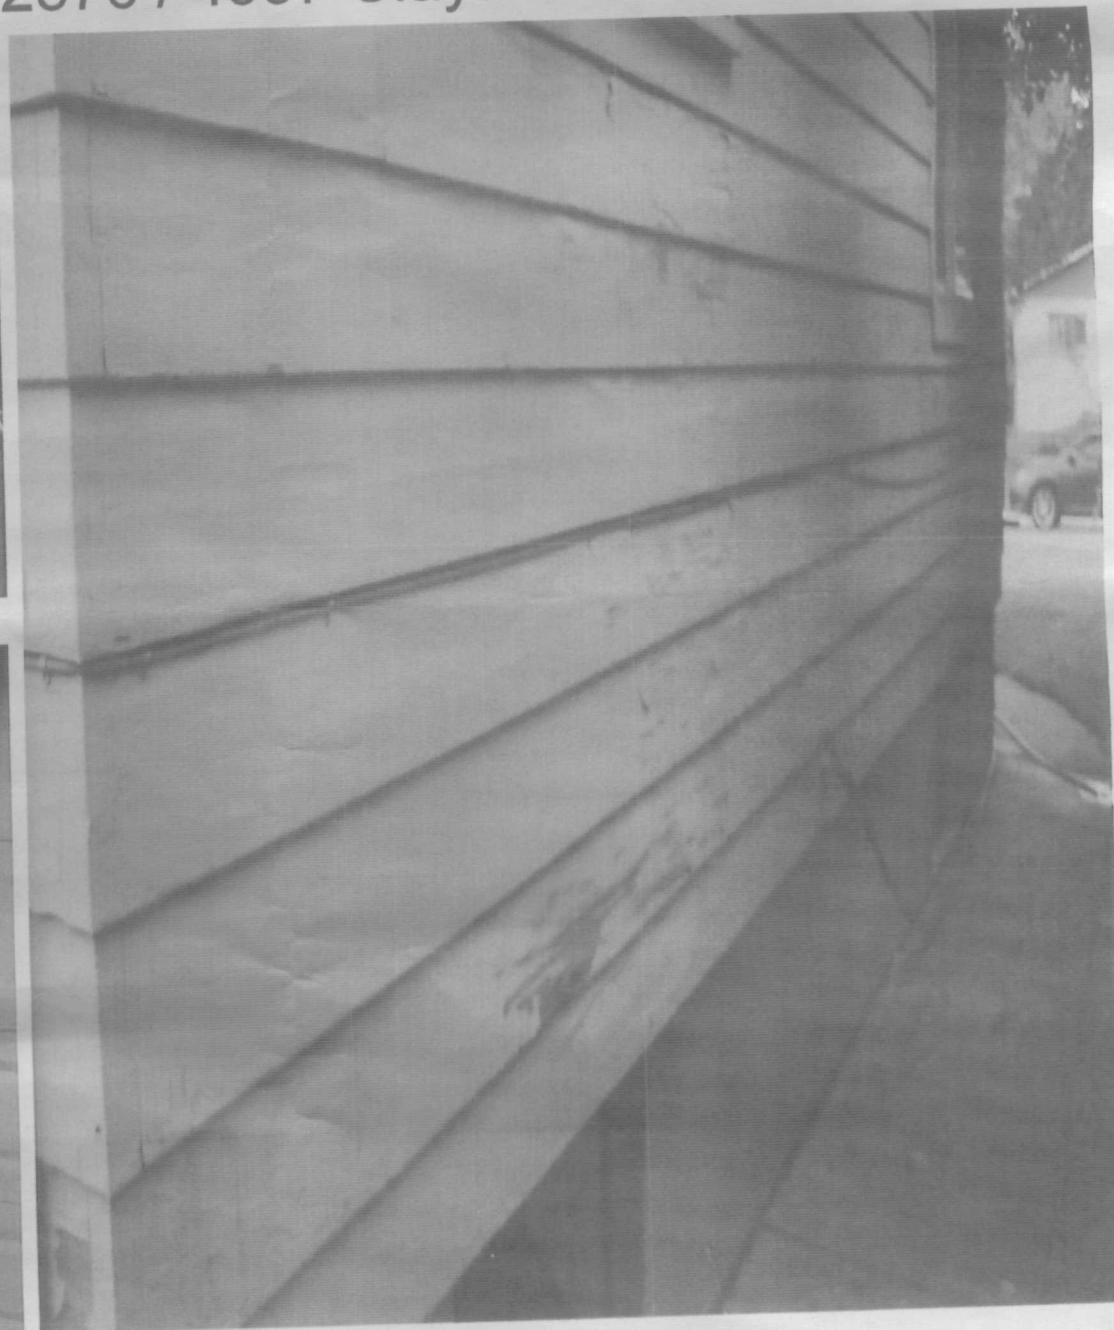
North exposure wall contains peeling lead paint

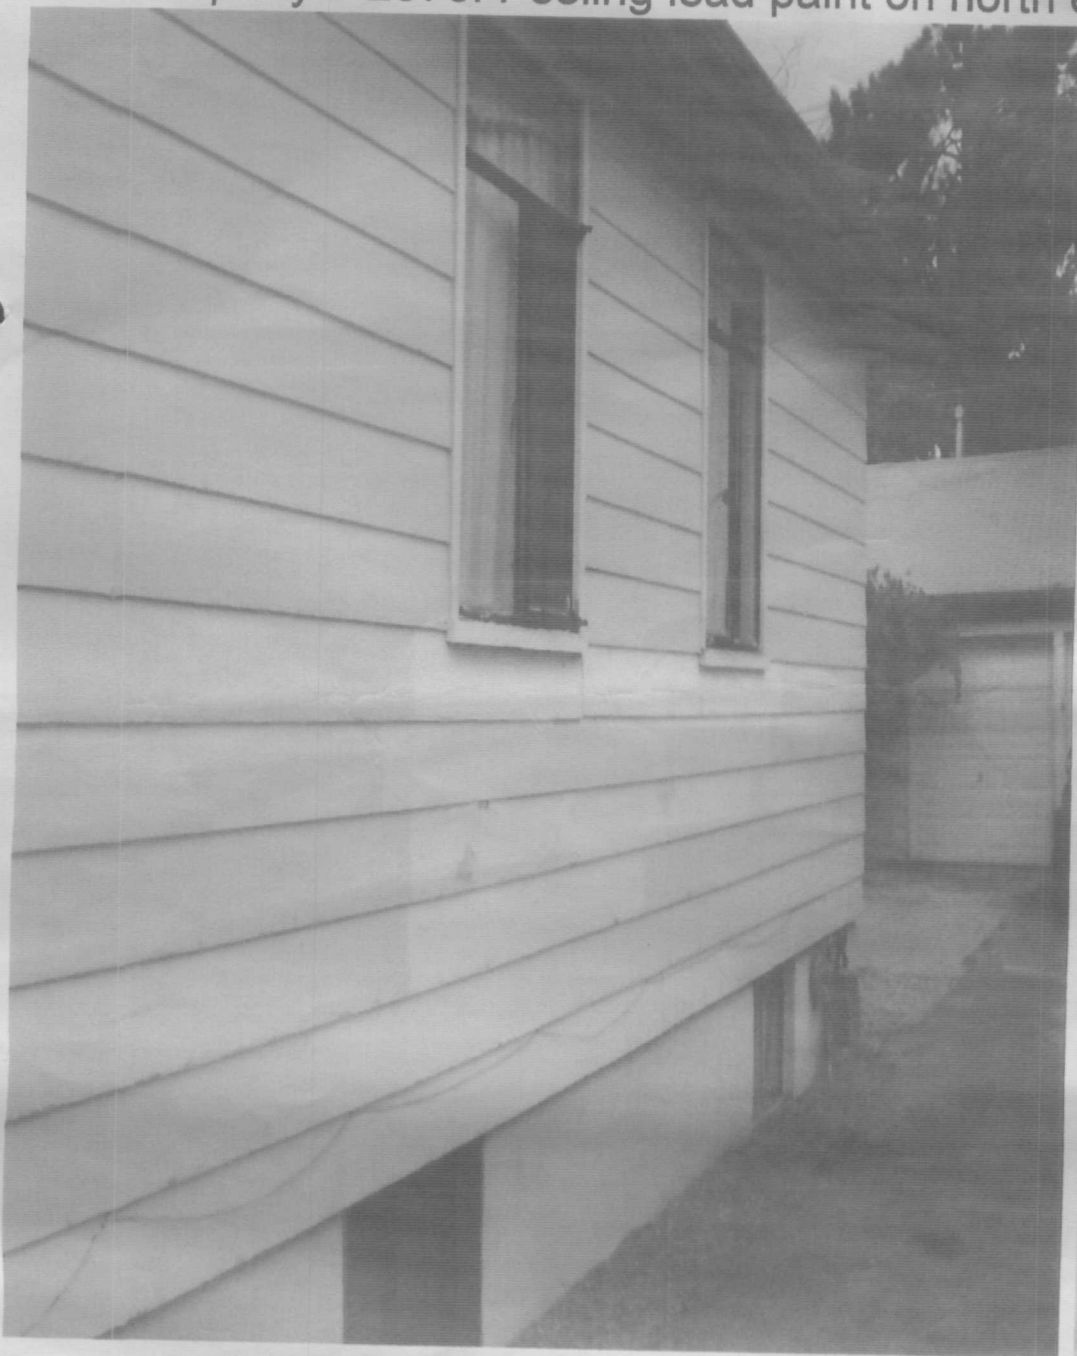
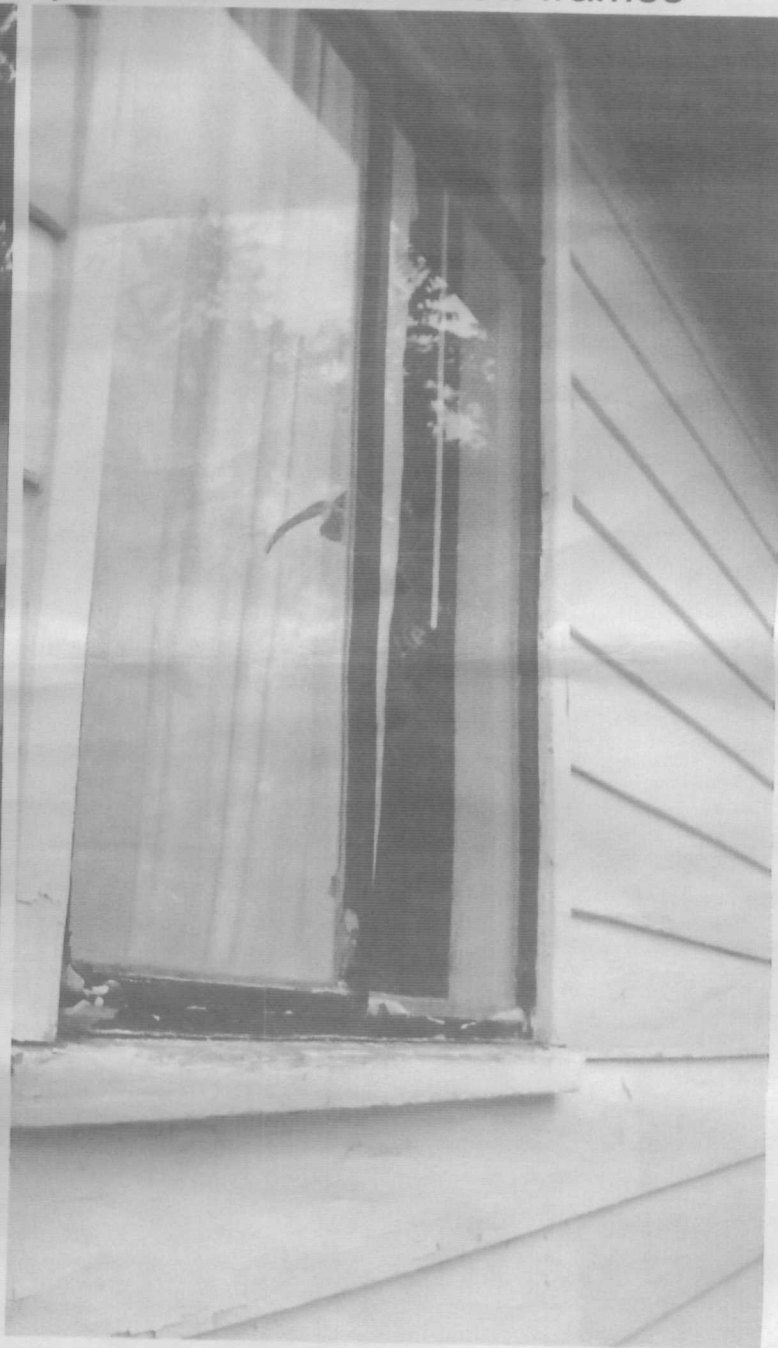
Property # 2576: Peeling lead paint on north exposure walls & window frames

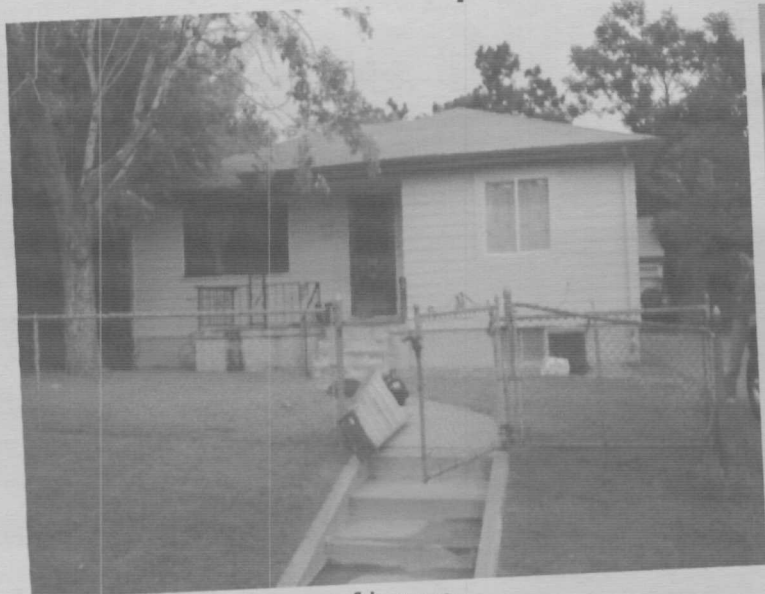
East porch exposure of house

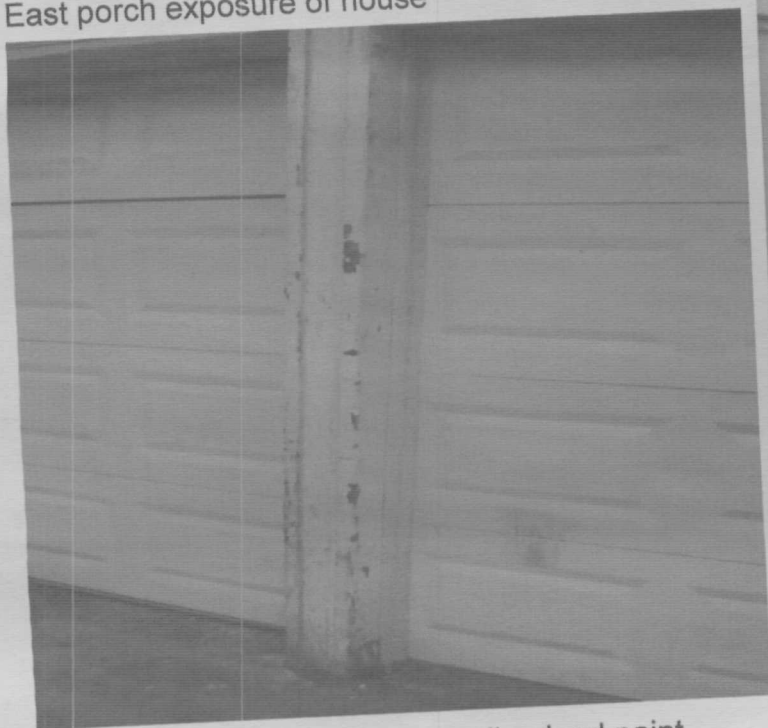
Garage doorframe contains peeling lead paint

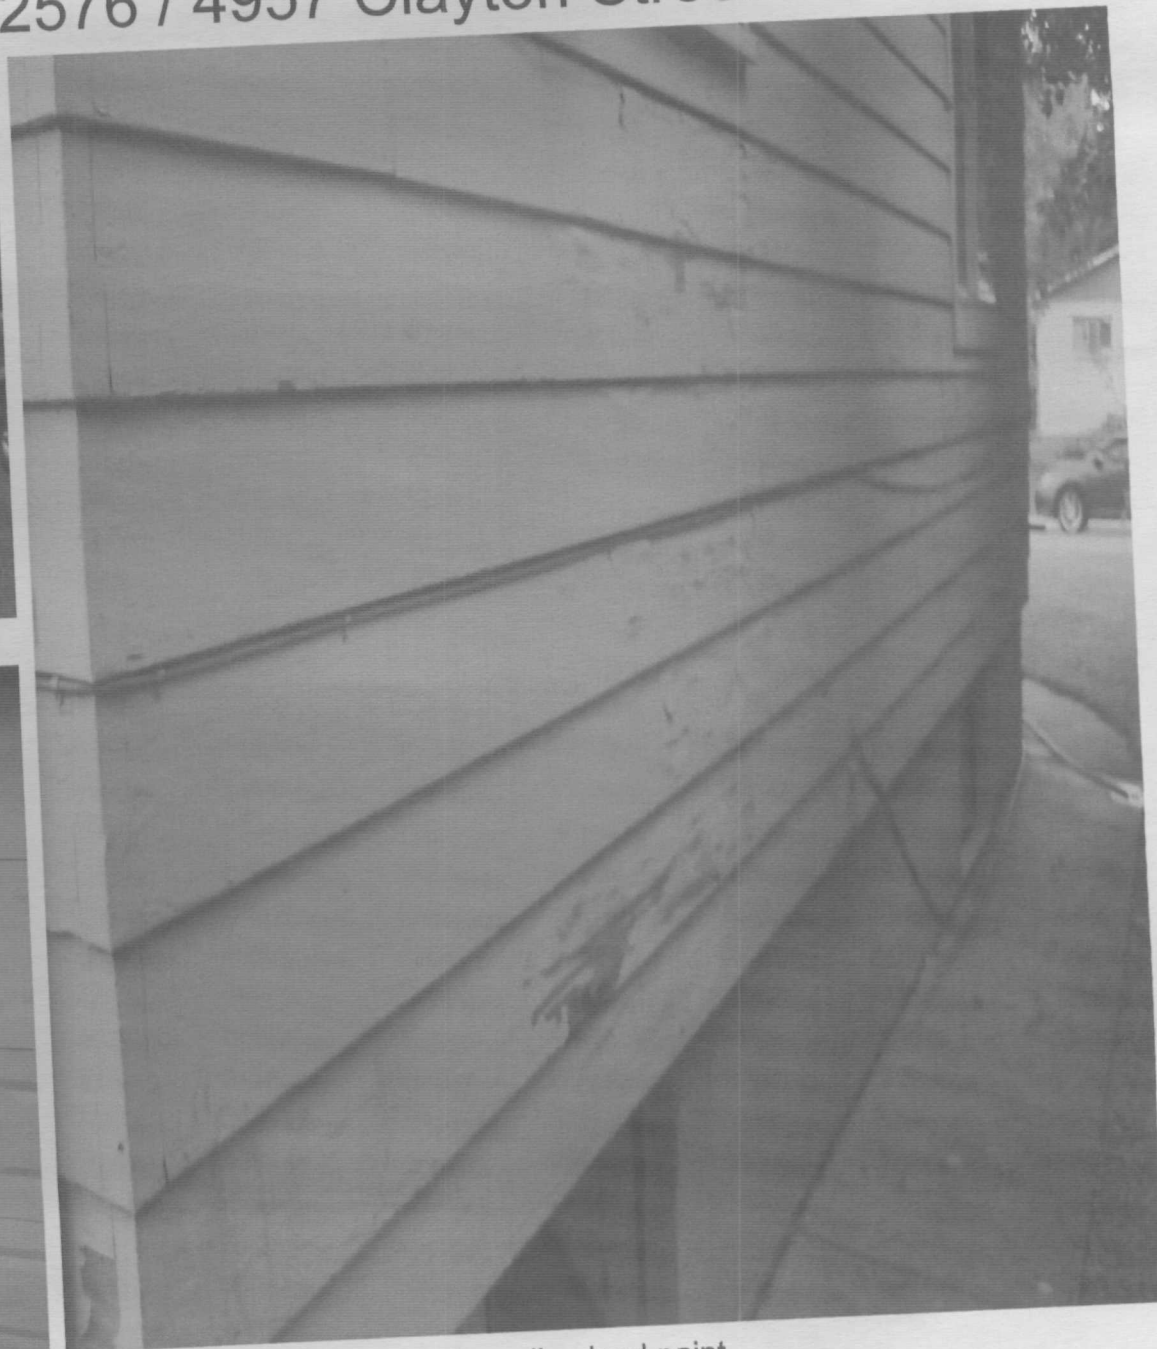
North exposure wall contains peeling lead paint

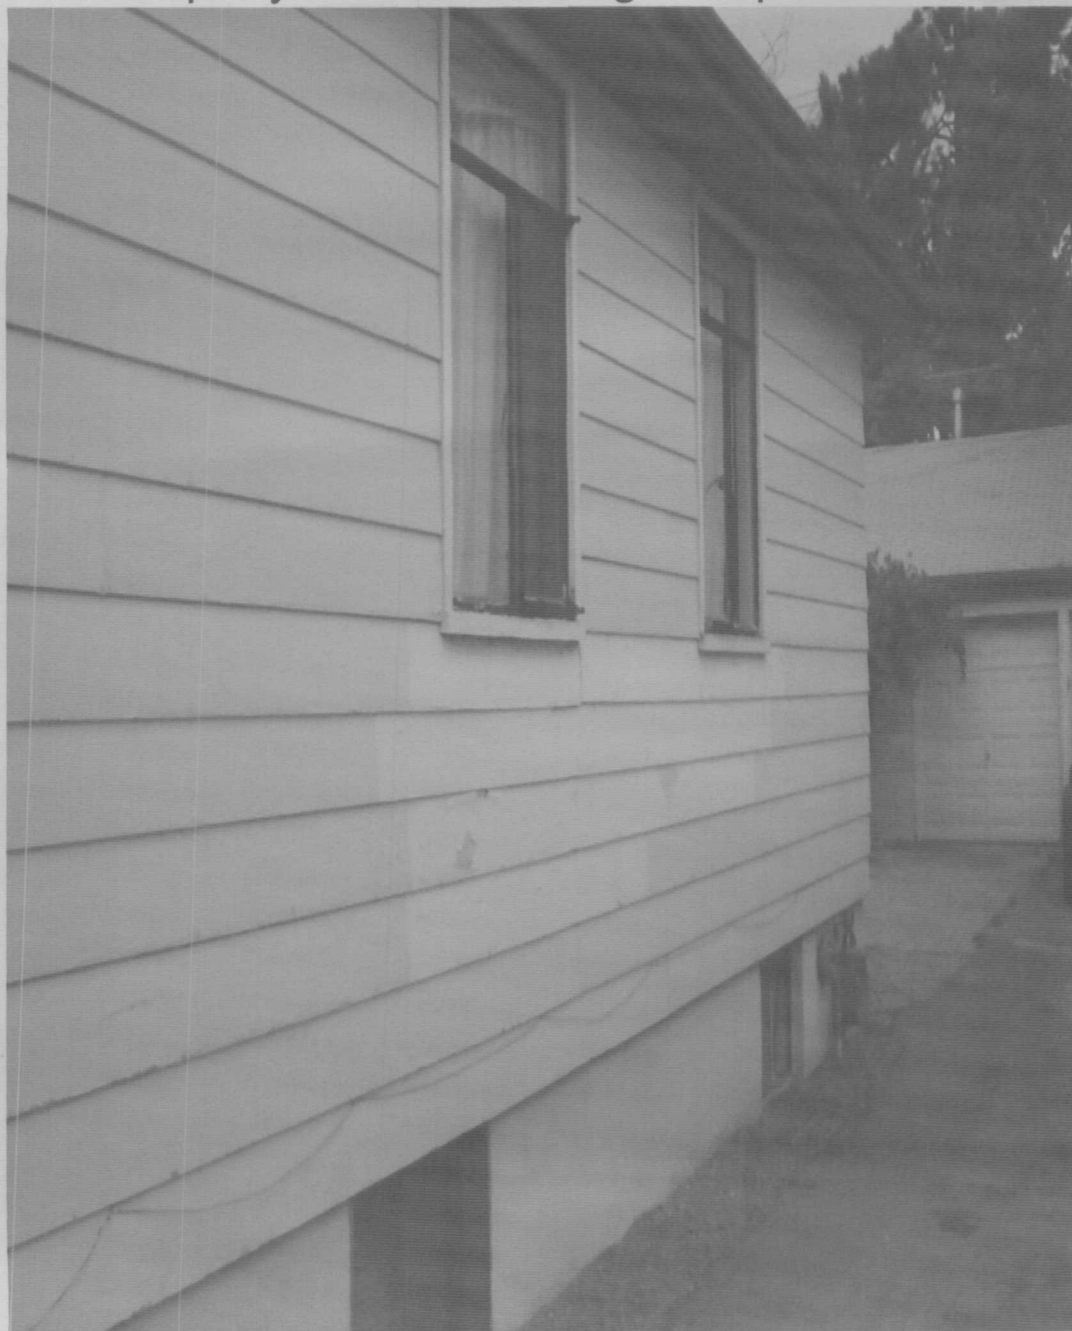
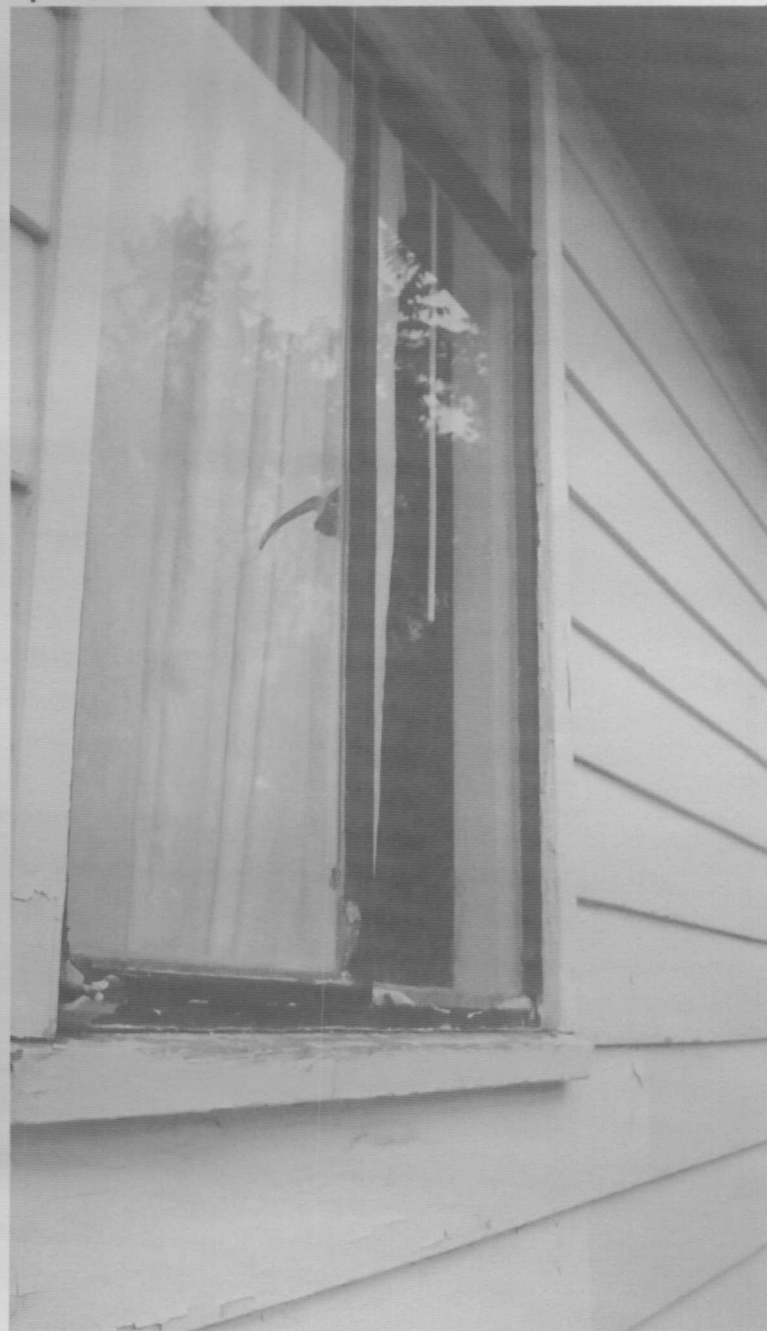
Property # 2576: Peeling lead paint on north exposure walls & window frames
